# Manhole Inspection Summary

Manhole # S13A\_\_024MH

Insp Date: **12/3/07 2:26 PM**

**Location** Address: **REAR OF 2864 LANVALE ST** Cross Street: **POPLAR GROVE ST**

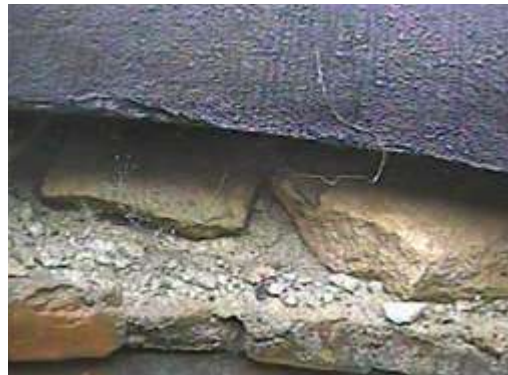
Defect 1

Condition: ☐ Sound ☐ Cracked ☐ Root Intrusion ☒ **Loose Brick** ☒ **Deteriorated**

LOOSE BRICKS AND DETERIORATED  
ADJUSTMENT

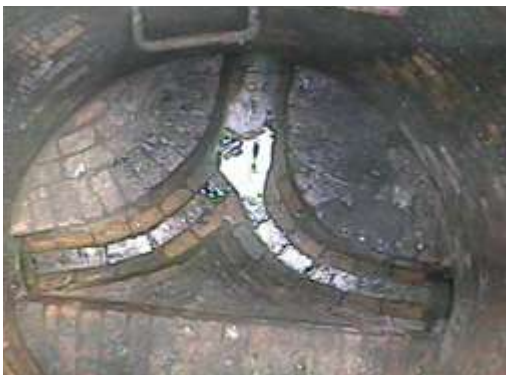
Defect 2

**Steps** Count: **2** Missing: **1** ☒ **Corroded**

CORRODED STEP

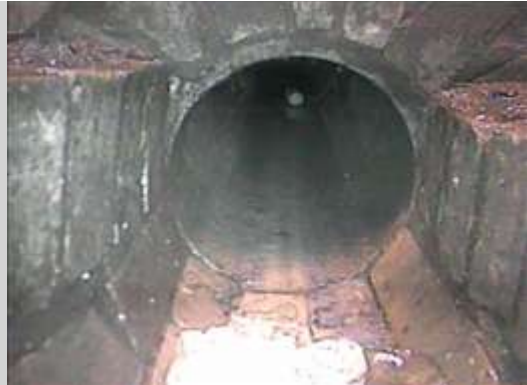
12 O'Clock Outflow

8 in. Circular Gravity Sewer  
Pipe Out @ 12 O'Clock

Pipe Material: **Clay** ☐ Pipe Lined

Invert Depth: **6.43** (ft.) Flow Characteristics: **None**

Deposits: ☐ None ☐ Mud ☐ Sludge ☒ **Debris** ☐ Grease

Silt Depth: **0** (in.) Deposits Extent: **Light**

Infiltration: **None** Pipe Seal Cond: **Sound**

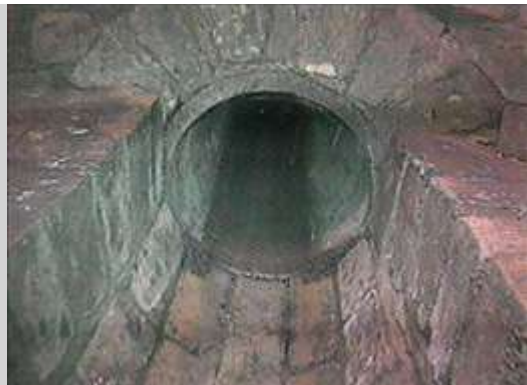
3 O'Clock Inflow

8 in. Circular Gravity Sewer  
Pipe In @ 3 O'Clock

Pipe Material: **Clay** ☐ Pipe Lined

Invert Depth: **6.29** (ft.) Flow Characteristics: **None**

Infiltration: **None** Pipe Seal Cond: **Sound**

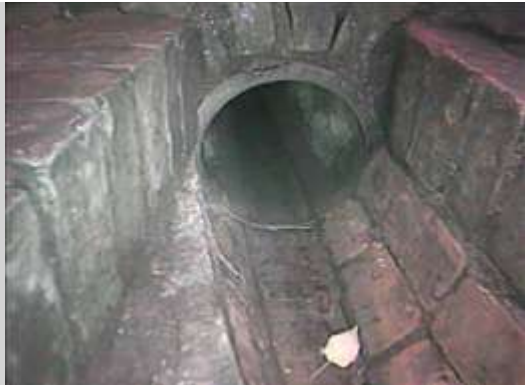
9 O'Clock Inflow

8 in. Circular Gravity Sewer

Pipe In @ 9 O'Clock

Pipe Material: **Clay** ☐ Pipe Lined

Invert Depth: **6.05** (ft.) Flow Characteristics: **None**

Connects To: **House connection / Service line**
